THE INFLUENCE OF THERMOMECHANICAL PROCESSING  
AND HEAT TREATMENT ON THE FATIGUE RESISTANCE  
AND FRACTOGRAPHIC CHARACTERISTICS OF  
A HIGH-CARBON BEARING STEEL

# NAVAL POSTGRADUATE SCHOOL

# THESIS

December 1979

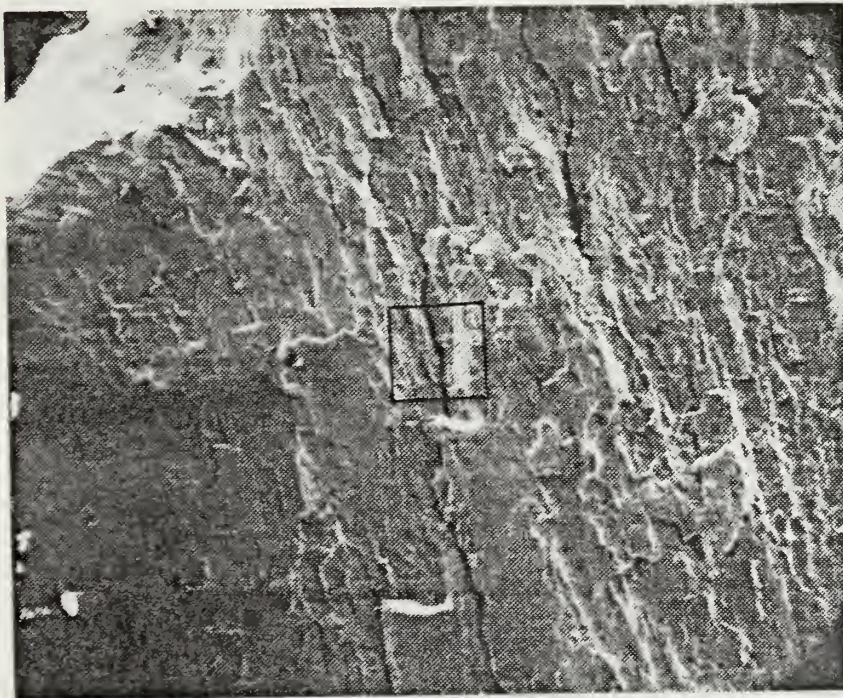
Figure 22. Area outlined by the rectangle in Fig. 21 at higher magnification in SEM, which shows secondary cracks parallel to the specimen surface and normal to the rolling direction. X100.

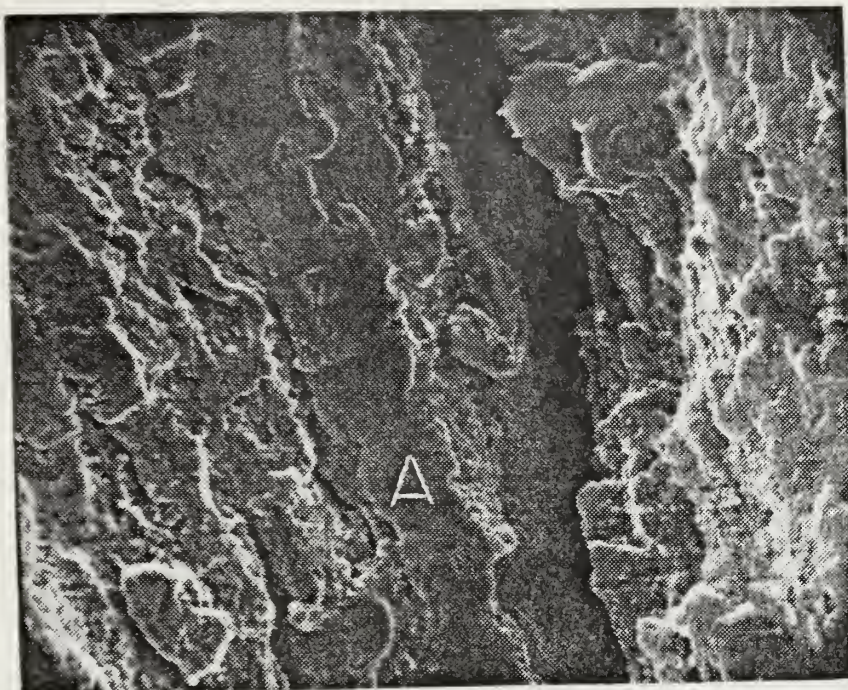
Figure 23. Area outlined by the rectangle in Fig. 22 at higher magnification. This fracture surface displays a progression of rather fine but extremely irregular striations, separated by secondary cracks. Cleavage facets are visible at A. X1000.

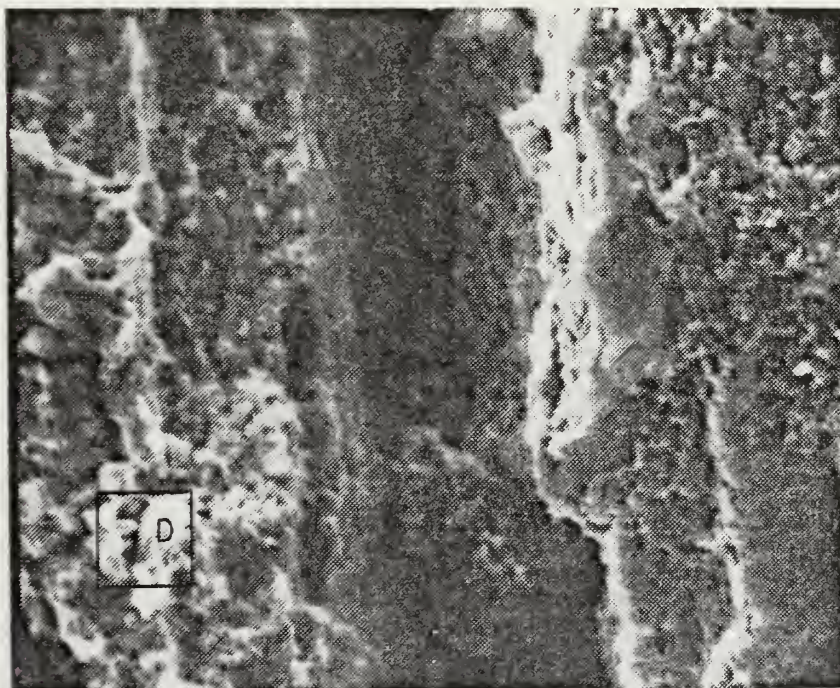
Figure 24. Another secondary crack on the fracture surface at higher magnification. This fracture surface displays fine microvoid coalescence and tear ridges, shown at D. X2000.

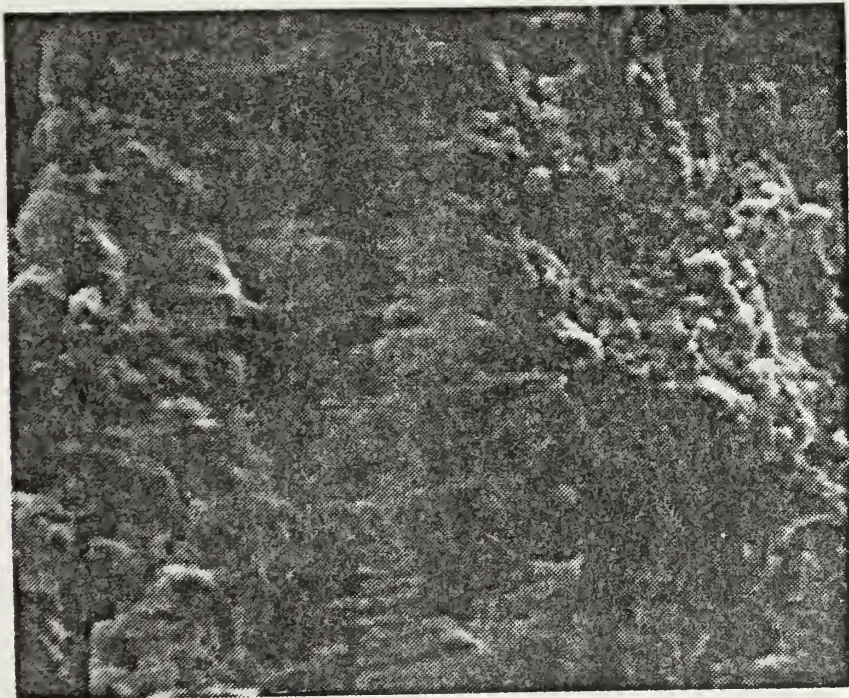
Figure 26. Area outline by the rectangle in Fig. 25 at higher magnification showing tear ridges, cleavage facets, microvoid coalescence and secondary cracks. X2000.

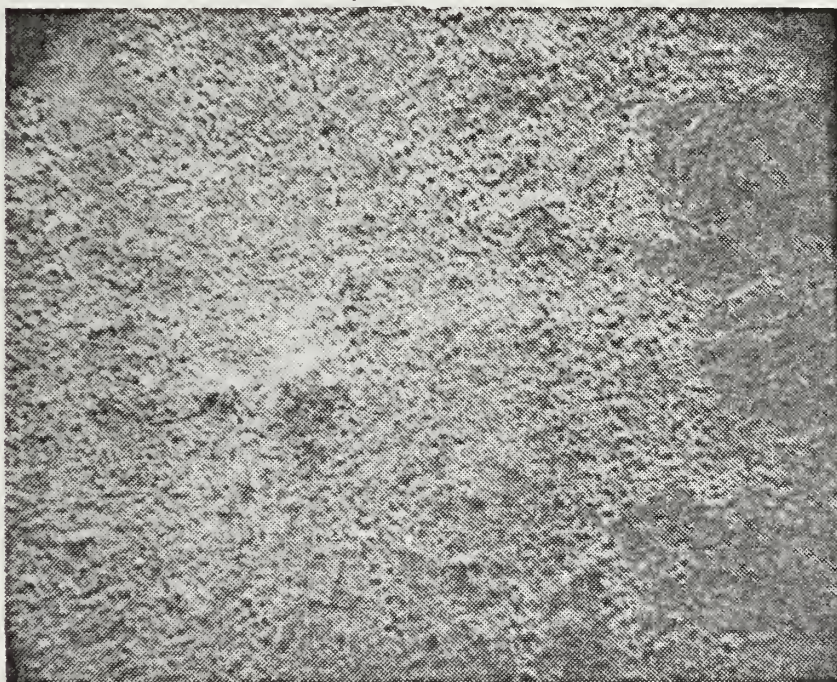
Figure 35. SEM micrograph of an electro-polished and ion-etched sample showing fine carbide particles dispersed in a ferrite matrix. X5000.

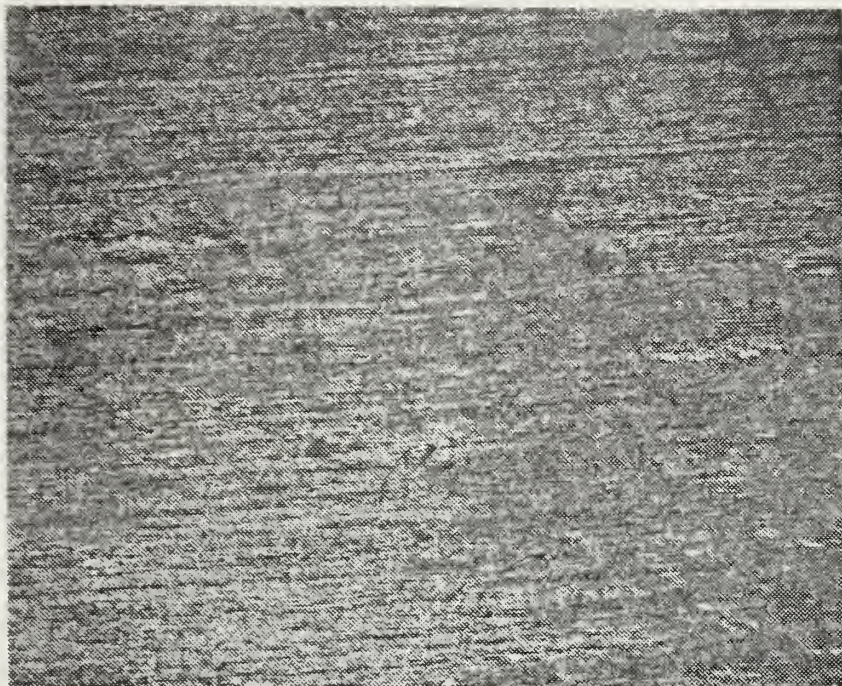
Figure 42. Micrograph of specimen AR-4-10 in Fig. 39, etched with 2% nital + 2% picric acid solution for 10 seconds. The rolling direction is parallel to the plane of the specimen and horizontal in the micrograph. X100.

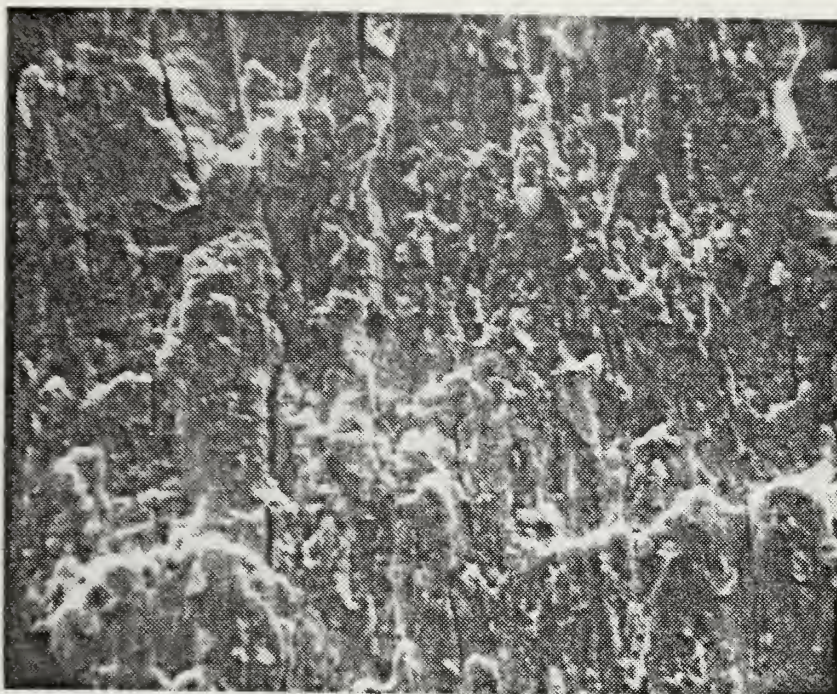
Figure 50. Higher-magnification view of the outlined area in Fig. 49, showing quasicleavage fracture with tear ridges. X1000.

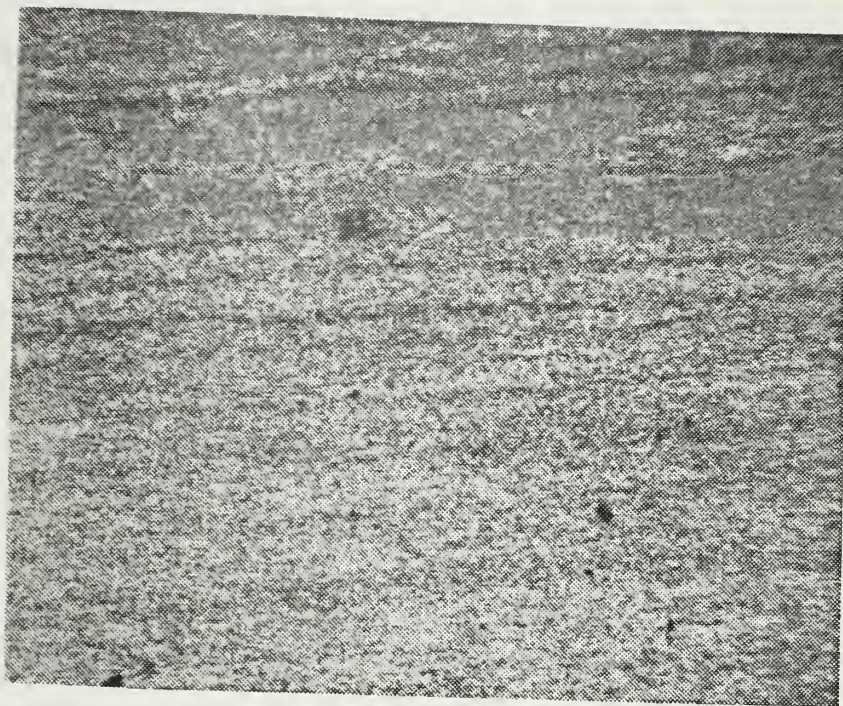
Figure 86. Microstructure of same specimen as in Fig. 85 (RI-1-6), etched in 2% nital + 2% picral solution for 10 seconds, showing banded carbide particles. X100.

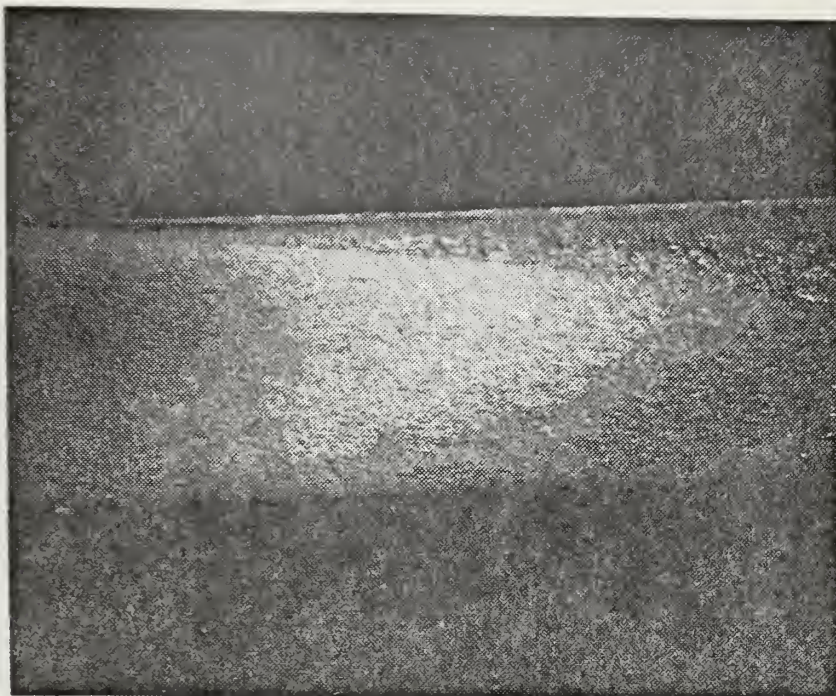
Figure 90. Macro-fractograph of a specimen RI-2-6 which was fractured after 215,700 cycles at 53 ksi, showing that the fatigue zone occupies almost the entire fracture surface. This means that this material has good fracture toughness and fatigue performance. X10.
